The Clay Research Group

Monthly Bulletin

Tree Supplement

August 2006.

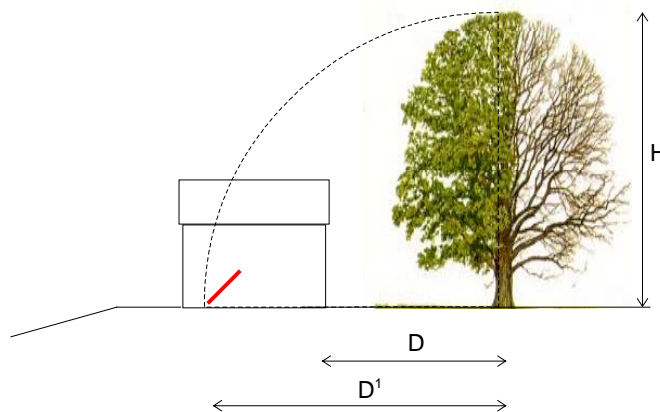
As we suggested on the previous page, the distance between the tree trunk and the building isn't the best way of determining tree root influence and risk zones, although it is of course a starting point.

Take the example where a long wall starts say 1mtr from the tree trunk and cracks appear 4mtrs away. The H/D value is largely meaningless.

It would appear from our study that the real zone of root influence is best determined by measuring to the base of the crack - this is the fulcrum of movement.

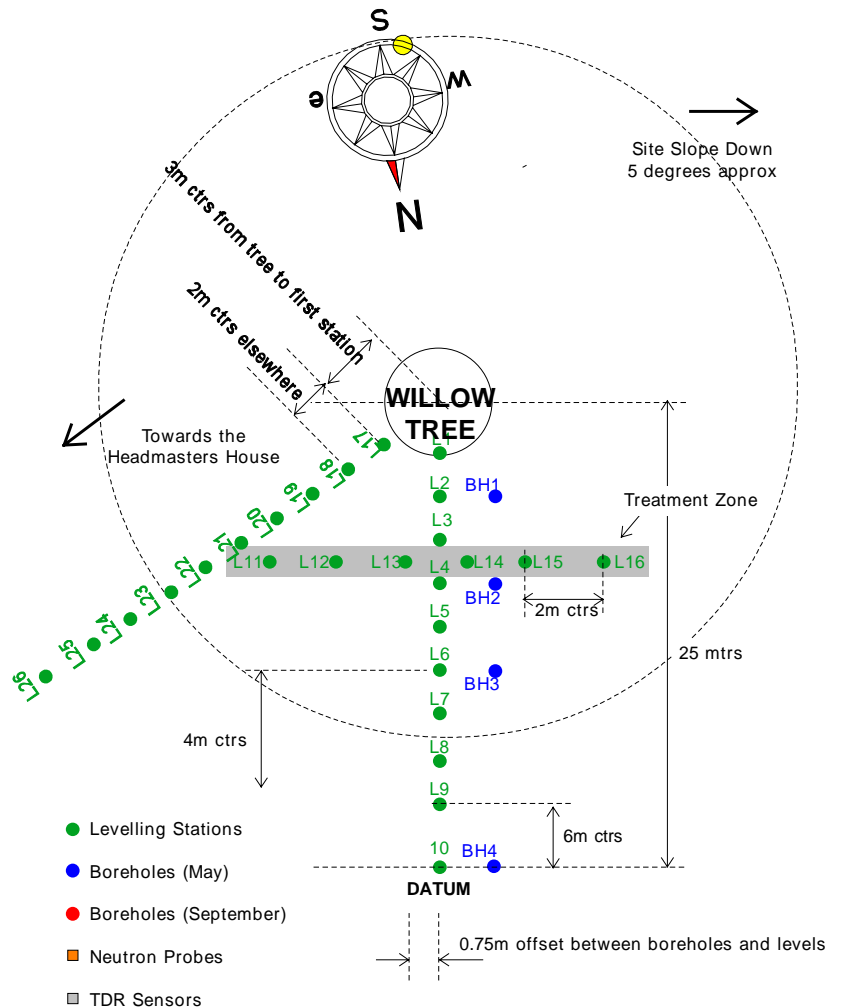
The willow occupies a gently sloping site (around 5 degrees, sloping down to the West boundary) and the instrumentation is as shown, right. Level stations 1 through to 10 (the datum) are oriented 10 degrees off the North point.

We have a treatment zone and will be sinking boreholes and testing soils and we are taking ERT readings every month. Because of the amount of labour required and the cost of the sensors and dataloggers etc., we will not have the array of TDR sensors and neutron probes.

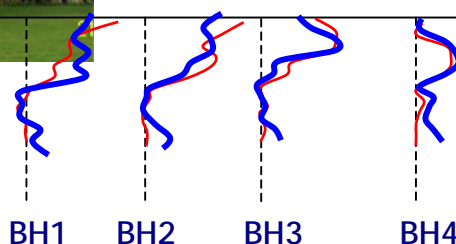
Oedometers
Suctions

The results of the soils investigations taken in May reveal very little difference between the soil suctions (using the filter paper) and the oedometer test using disturbed samples for both. This confirms the results from the Oak site.

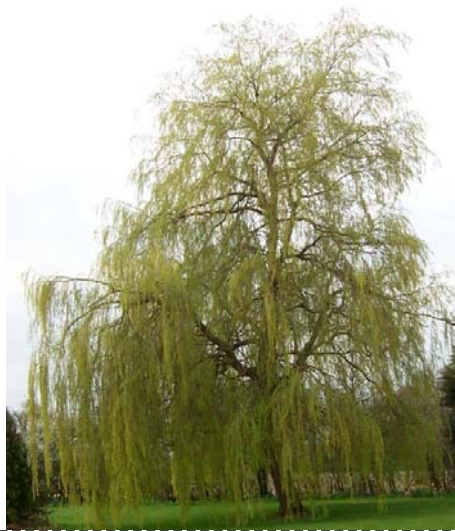
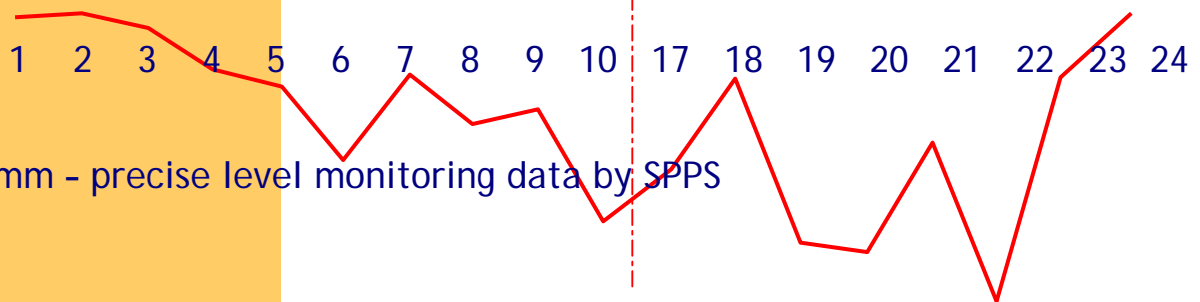
Scale - 0 - 14mm - precise level monitoring data by SPSS

The maximum movement (downward) recorded between May and June was 10.9mm at Station 20 (see plan).

Movement was significantly more along stations 17 - 25 in general (to the right of the photograph below) and more gradual and of less amplitude on the North facing array.

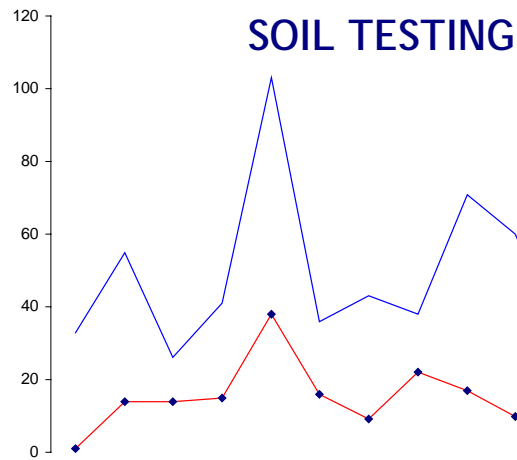
In 8% of cases the actual soils data (blue line) over-estimated the estimate of swell due to incorrect plotting of the K_0 line. Here, the modelling application was probably closer to the correct values if we made the necessary adjustment. This also reflects the natural tendency for estimates based on soils data to over-estimate recovery.

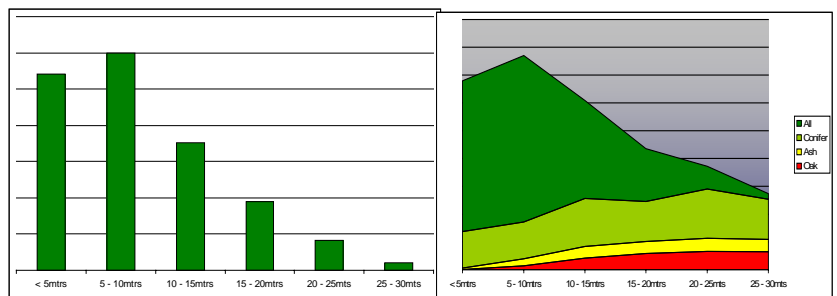
Left is the height distribution of all trees in 5mtr bands. Right, we plot Oaks, Conifers and Ash against the entire population. The latter appear to become more of a threat as they grow, whilst the majority of trees peak at between 7 and 9mtrs.
